Manhole Inspection Summary

Manhole # S33K1_005MH

Insp Date: **3/24/08 10:01 AM**

Location Address: **2501 Seamon Ave.**

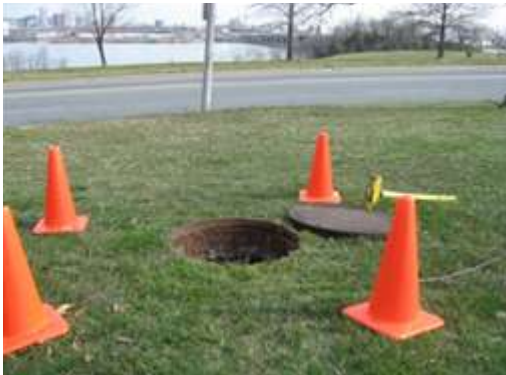
Location View

2501 Seamon Ave.

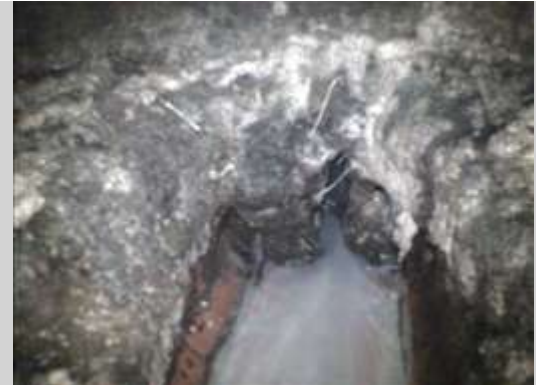
12 O'Clock Outflow
Pipe Out @ 12 O'Clock

Pipe Height: **8.4** (in.) Rod and Bar (Angled)
Pipe Material: **Clay** ☐ Pipe Lined
Invert Depth: **11.31** (ft.) Flow Characteristics: **Fast**
Deposits: ☒ None ☐ Mud ☐ Sludge ☐ Debris ☐ Grease
Silt Depth: (in.) Deposits Extent:
Infiltration: **None** Pipe Seal Cond: **Unknown**

Drop: **None**

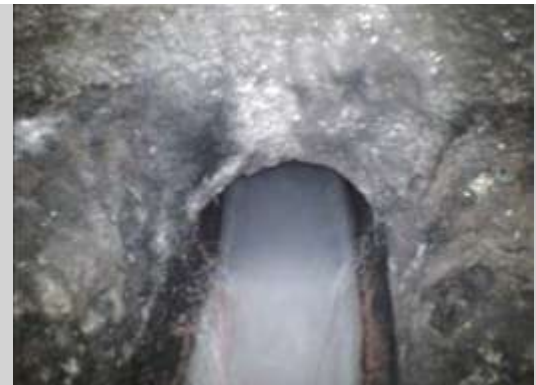
5 O'Clock Inflow
Pipe In @ 5 O'Clock

Pipe Height: **8.4** (in.) Rod and Bar (Angled)
Pipe Material: **Clay** ☐ Pipe Lined
Invert Depth: **11.13** (ft.) Flow Characteristics: **Fast**
Deposits: ☒ None ☐ Mud ☐ Sludge ☐ Debris ☐ Grease
Silt Depth: (in.) Deposits Extent:
Infiltration: **None** Pipe Seal Cond: **Sound**

Drop: **None**
